Technical photography for mural paintings: the newly discovered frescoes in Aci Sant'Antonio (Sicily, Italy)

A cycle of 18th century frescoes, depicting the last days of Christ on earth, were recently discovered in Aci Sant'Antonio (Sicily, Italy). The paintings survive along the corners of an originally square chapel that was altered in the early 20th century, acquiring the current octagonal plan. This paper presents the results of the technical photography documentation of these wall paintings and illustrates the methodological challenges that were posed during their examination. Raking light photography was used to reveal the paintings' state of conservation, details of the plaster work and painting techniques. Ultraviolet fluorescence and infrared false color photography were also performed to evaluate areas of interest for further analytical and diagnostic studies. The first striking feature is the lack of *giornate*. Only *pontate* are clearly seen in all the scenes thus indicating that in the larger paint areas, a mixed of fresco and secco technique would have been used.

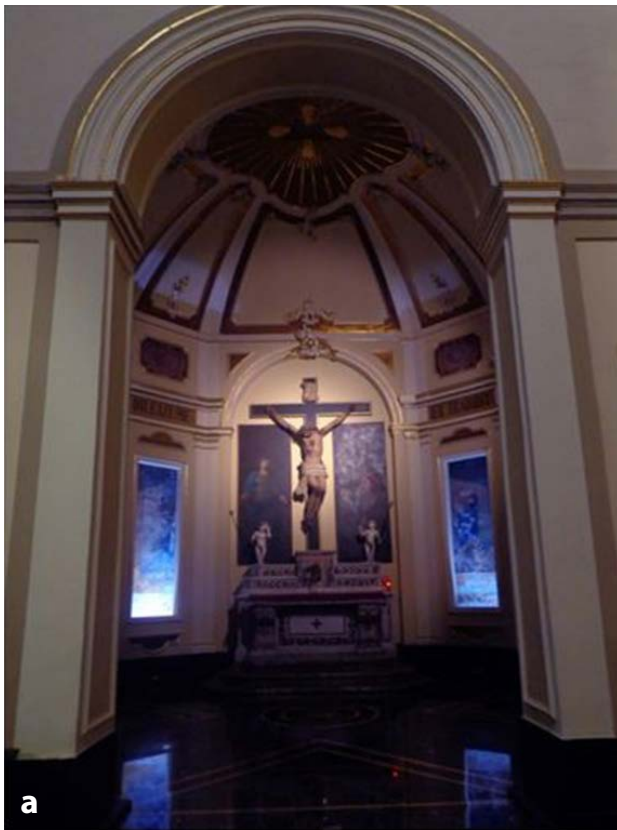
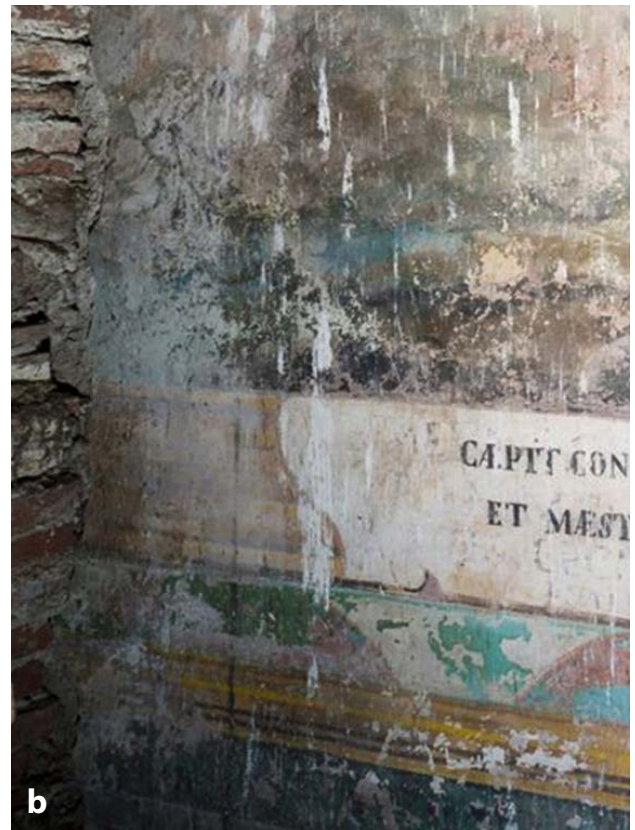
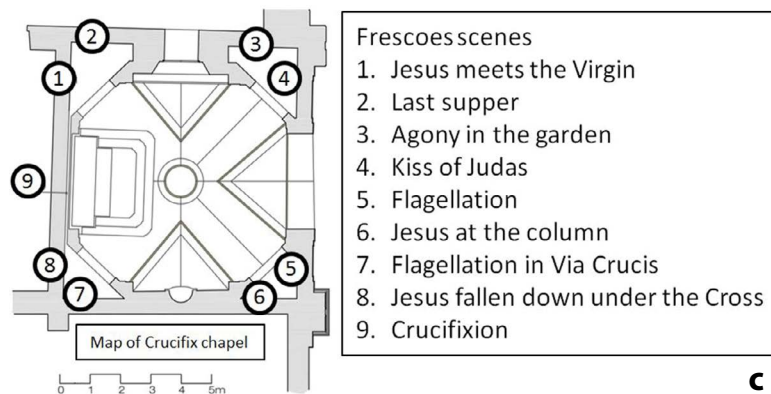
Figure 1. Crucifix Chapel, Mother Church, Aci Sant'Antonio (Sicily): *a*) photo of the chapel from the transept after the renovation; the frescoes are visible through the windows on the walls facing the four corners; *b*) border of the third scene, Agony in the garden; the original plaster was taken down in order to anchor the new wall; *c*) floor plan with the description of the scenes.

The examined frescoes were revealed during maintenance works carried out in 2012 in the Crucifix chapel of the Mother Church in Aci Sant'Antonio (Sicily). This church was originally built in 1566 and dedicated to Sant'Antonio. Soon after the destructive earthquake, which struck the south-east part of Sicily in 1693, the church was rebuilt with a Latin cross scheme composed of three naves, a transept and five chapels. The church preserves significant works of art, of which the most celebrated, the frescoes by Pietro Paolo Vasta (1697-1760), can be found decorating the apse. The Crucifix Chapel is located on the left of the transept and has an octagonal floor plan dated to the beginning of the 20th century which has been realized within the original square plan (Figure 1). The

newly discovered mural paintings were preserved along the four corners of the original walls, while other sections of the fresco cycle have been irremediably lost, since new walls were added to the original ones to form the current octagonal plan. The inspection of the interface between the original walls and the later additions shows that no effort was made to preserve the original decorations (Figure 1). There are eight scenes which were preserved and they represent themes of the last days of earthly Christ: Last Supper; Jesus meets the Virgin; Agony in the garden; Kiss of Judas; Flagellation; Jesus at the column; Flagellation in Via Crucis; and Jesus fallen down under the Cross and Crucifixion.

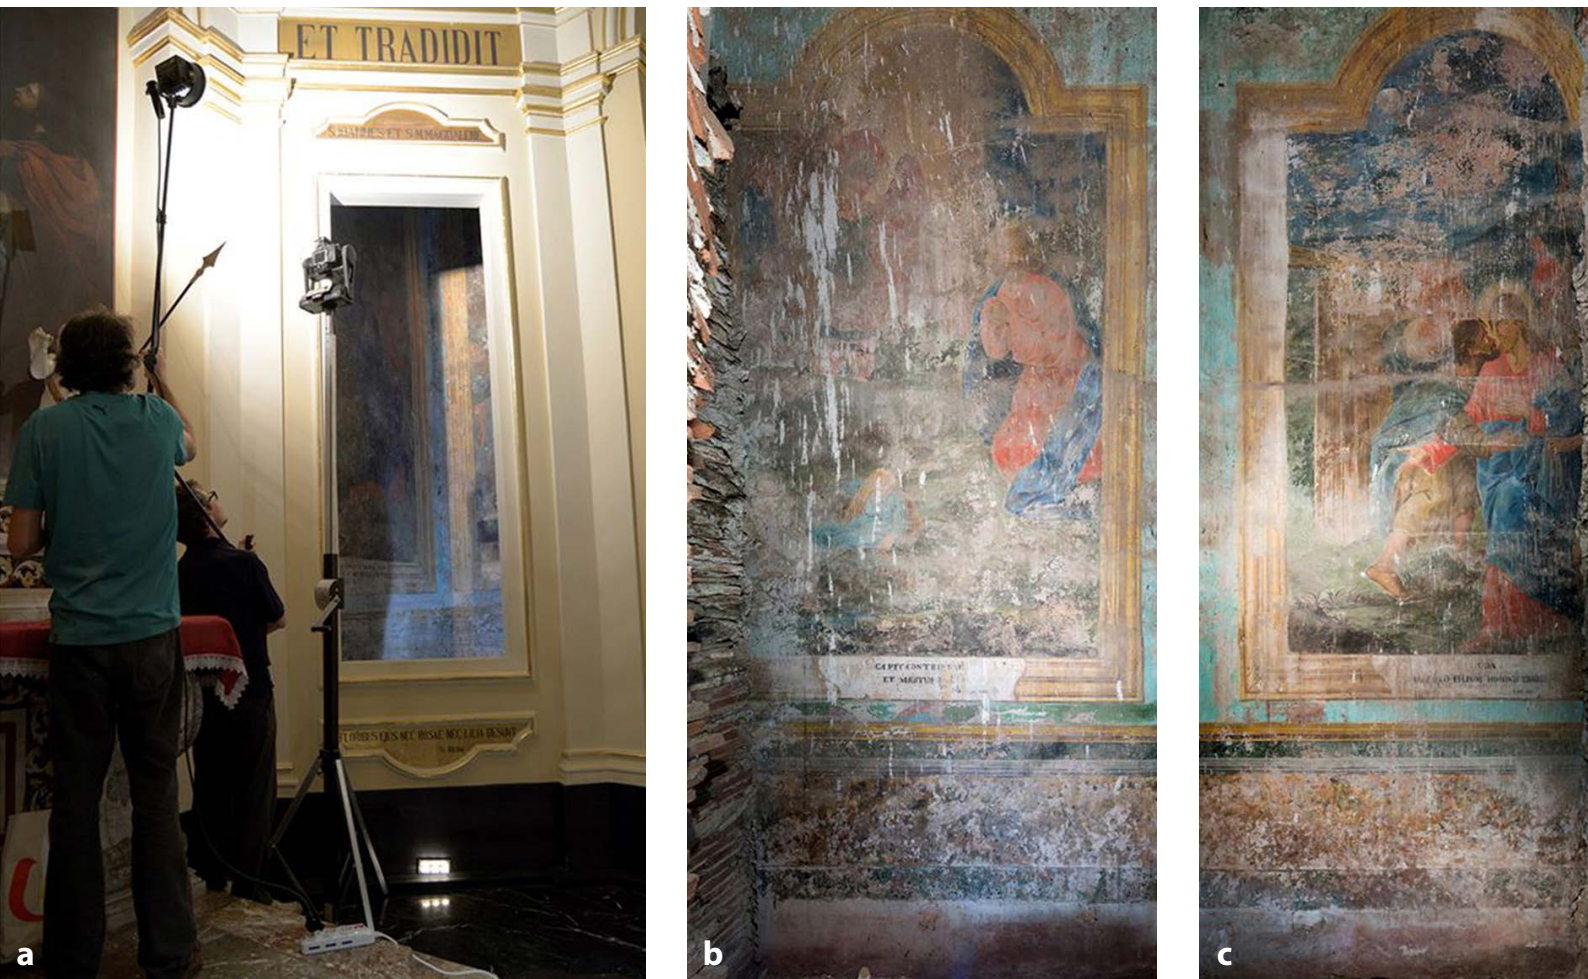
Figure 2. Crucifix chapel: *a)* NW corner. The early 20th century octagonal addition allows only a restricted field of view from outside. The camera was mounted on a telescopic pole and the documentation of the mural paintings was achieved with the mosaic method after shooting a stripe of vertical images; *b)* and *c)* SE corner, documentation of the frescoes realized with the panoramic method from inside the enclosure.

After their discovery in 2012, the decision was made to preserve the early 20th century octagonal shape of the chapel and make the frescoes in the corners visible by way of large windows (Figure 2). While this solution is appealing for the visitors, since it provides an understanding of the modifications undergone by the chapel, it makes the photographic documentation of the paintings problematic because of the restrained field of view offered by the windows. The photographic documentation of all the murals is essential in order to formulate the plan for a conservation intervention to clean and consolidate the art works. On the first examination campaign [4], two of the paintings were documented using the panoramic photographic method. The camera was located outside the windows and at 5 m from the murals. The images were taken with a 200 mm lens and a panoramic head. While the quality of the images was satisfactory, the previous panoramic approach resulted in the documentation of only a narrow stripe of each painted

During this study, the photographic documentation of the entirety of the wall paintings was achieved using the panoramic method. However, positioning the camera on a pole at 2.5 m (half the height of the fresco cycle) and inside the enclosure between the original walls and the 20th century additions provided for an increased field of view. The camera photographed the opposite wall mounting a Nikon Nikkor 20 mm f3.5 lens and shooting a vertical sequence of five photos. This method provided a complete documentation of the corners. The stitched image was spatially calibrated using the *Set Measurement Scale* tool in Photoshop [6]. The *Measurement Log* tool provides any other measure needed such as calculation of areas, feature particularly useful to estimate the conservation intervention costs and time. The other technical photos, RAK, UVF, IR and IR-RAK, were realized from outside the windows with a mosaicking method. The camera was applied on a telescope pole and five photos covering the frescoes from the bottom to the top were shot, as allowed by the windows' frame (Figure 2). This solution does not allow the documentation of the entirety of the surface for each scene but just the stripe accessible through the window. Nonetheless, it was chosen because the documentation of the stripe was sufficient to the study of the paintings and the complete documentation would have been extremely difficult and lengthy.

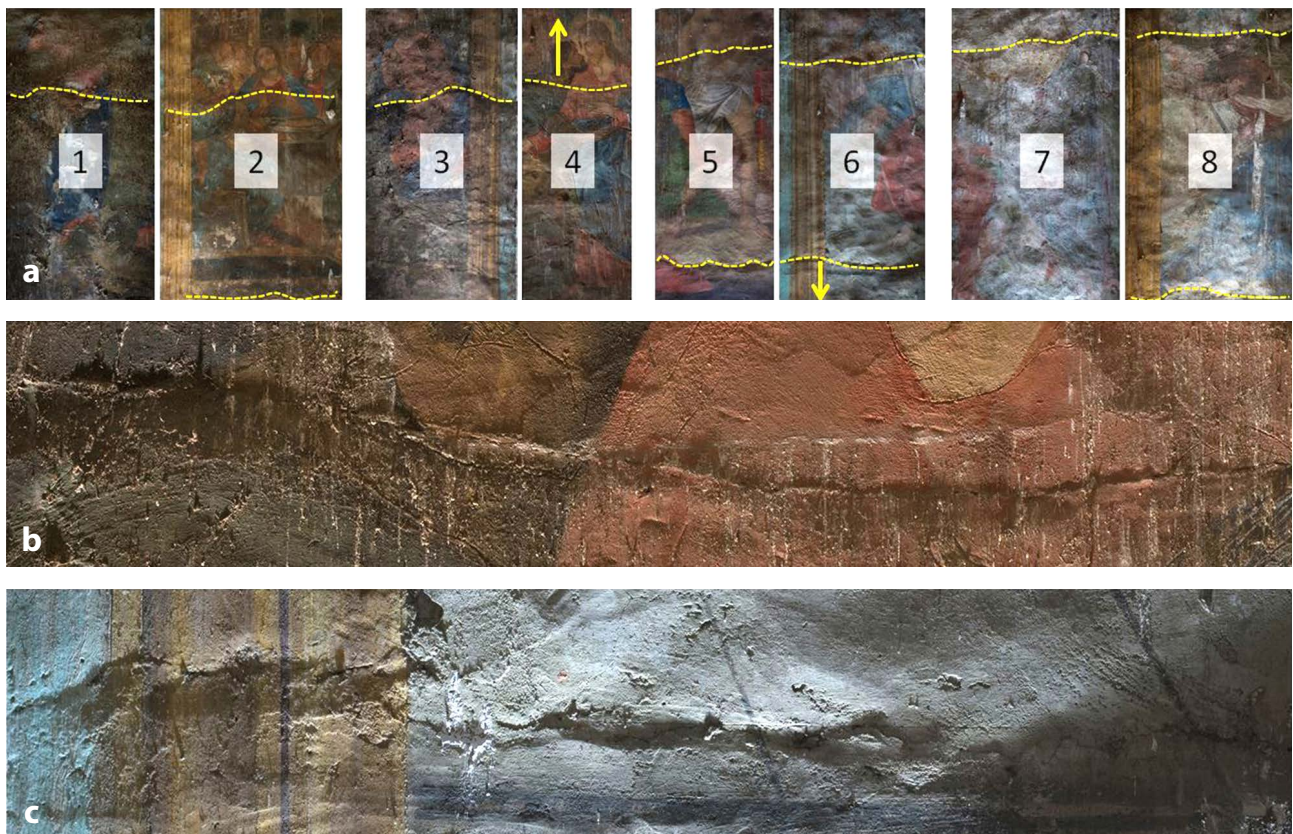
Figure 3. Maps of the pontate on the eight scenes (a) and two details of pontate in scene 4 (b) and 6 (c).

In the RAK photos, *pontate* are clearly visible in most of the scenes by the slight overlapping of the plaster on the *pontate* joints (Figure 3). At least two *pontate* are identified in scene 2, 5, 6 and 8 resulting in three horizontal painting registers. On scenes 1, 3, 4, and 7 only

one plaster joint was clearly observed. This could be due to the actual lack of the other *pontate* or, more likely, the joint was worked particularly smooth and consequently it could not be noticed on such an irregular and dirty surface. Overall, the surface of the *pontate*, even those close to the ground, is completed with coarse plaster. It is not as smooth as it would be expected, in particular, for the paintings on the bottom, nearest to the viewer. It is known that rough *intonaci* (outer plaster layer) were common in Baroque mural paintings to create textural effects [7] but this does not seem to apply for this case since it is not used for “effects” but rather without intention everywhere.

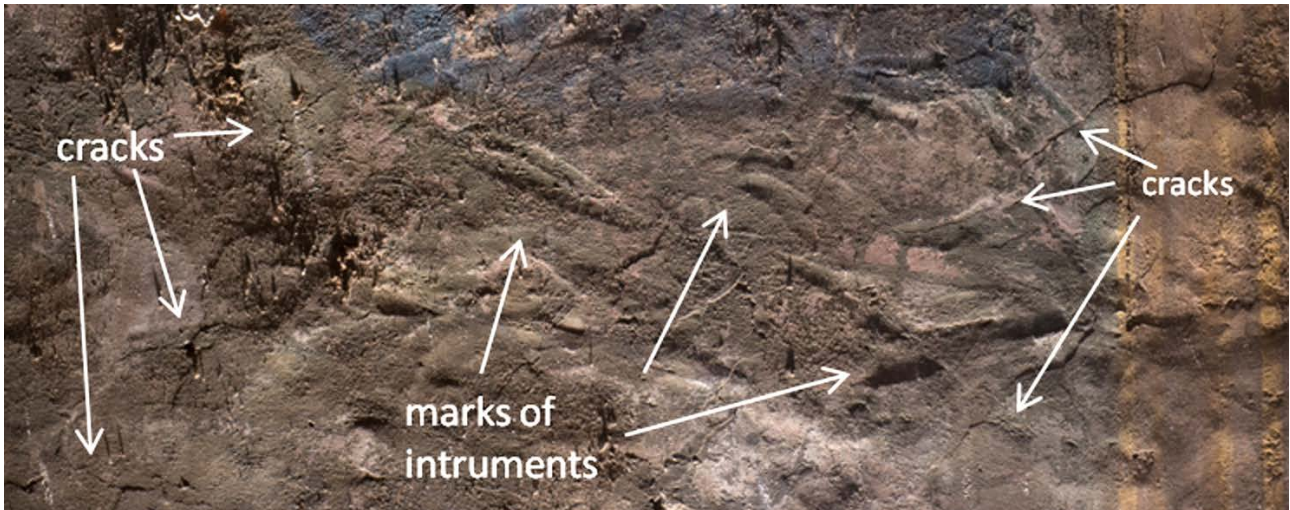
Figure 4. Scene 3, *Agony in the Garden*, detail. Cracks and marks of tools in the plaster.

Indeed, several marks from trowels and tools used to spread the plaster can be identified, as well as cracks formed during the hardening of the *intonaci*, suggesting a fast execution (Figure 4).

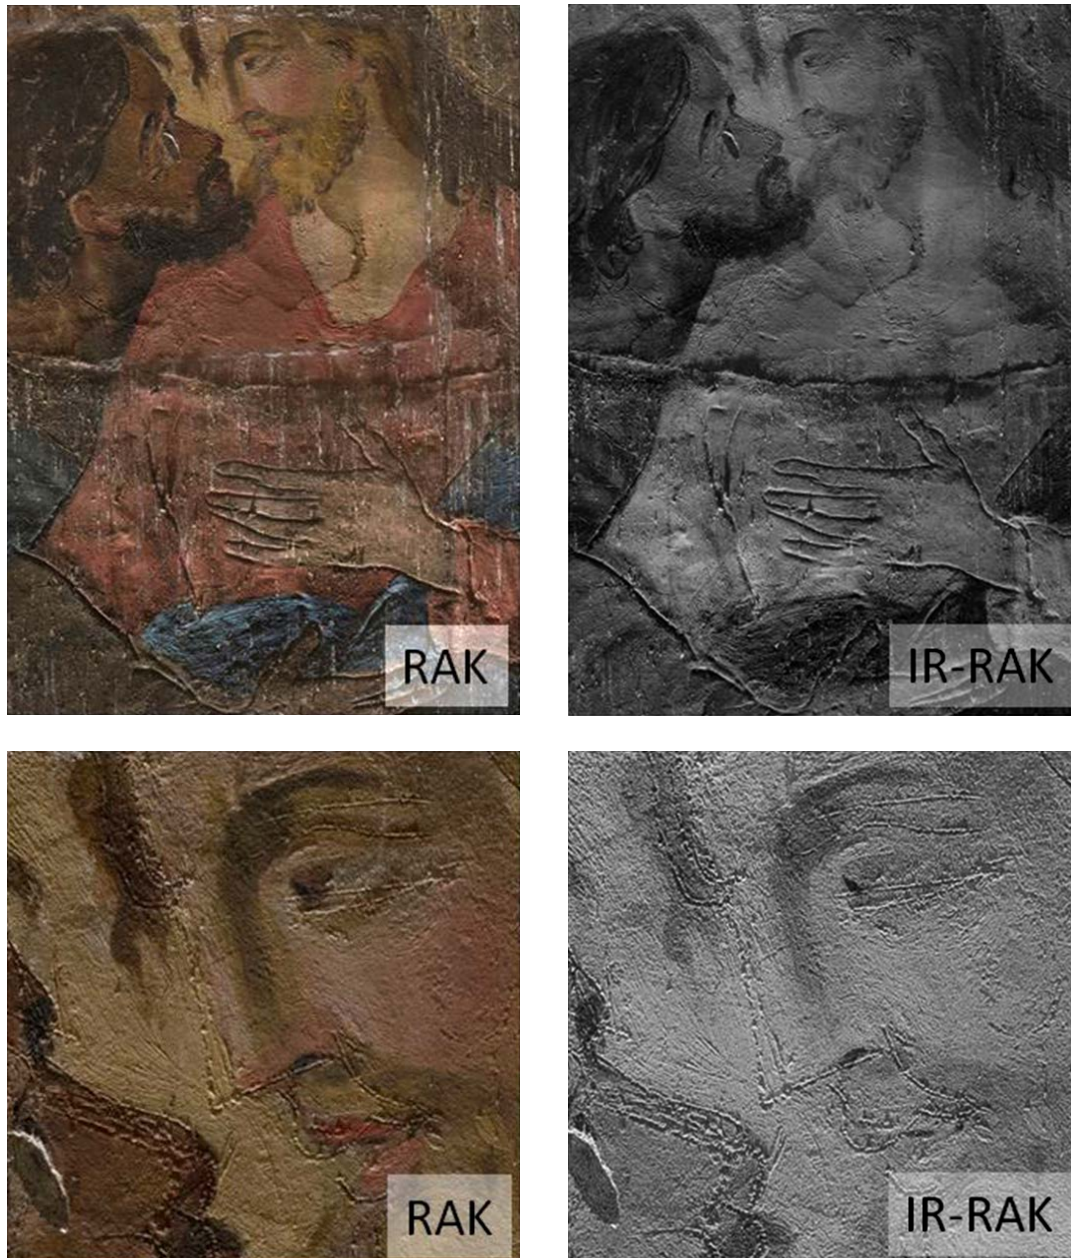
Figure 5. Scene 4, *Kiss of Judas*. Raking photo reveals the two types of incised drawing on the lower and upper pontata. Raking photography in the infrared (IR-RAK) increases the reading of the shallow incisions made with a pointed tool.

RAK photos also document the methods used to transfer the composition. The outlines of all of the figures revealed simply shallow lines engraved in the plaster. Curiously, only scene 4, Kiss of Judas, features a different incised drawing method on the lower *pontata* (Figure 5). The contour lines of the hands of Jesus and Judas are rounded groove, suggesting that they were made by the pressure of a pointed tool through a *cartoon*. On the other hand, the upper *pontata* with the faces of Christ and Judas shows just shallow incisions, such as the remaining scenes. Indeed, there are a number of lines indicating a free hand sketching for the contours (Figure 6). In general, the incised lines are sketchy and in some points have a grainy aspect which suggests that the plaster was almost dry. There are not substantial differences between the incised drawings and the final paintings except few small areas. While the *cartoon* traced with a point is immediately identified in the RAK light photo, the shallow incised lines are more difficult to identify, especially in the scenes on the north wall which are much more affected by salts,

pigment detachments, and dirt. Thus, these scenes have also been photographed in IR-RAK. These photos can render better the incisions since the contrast between the shadow of the lines and the ground is increased thanks to the transparency of the ocher pigments (Figure 5).

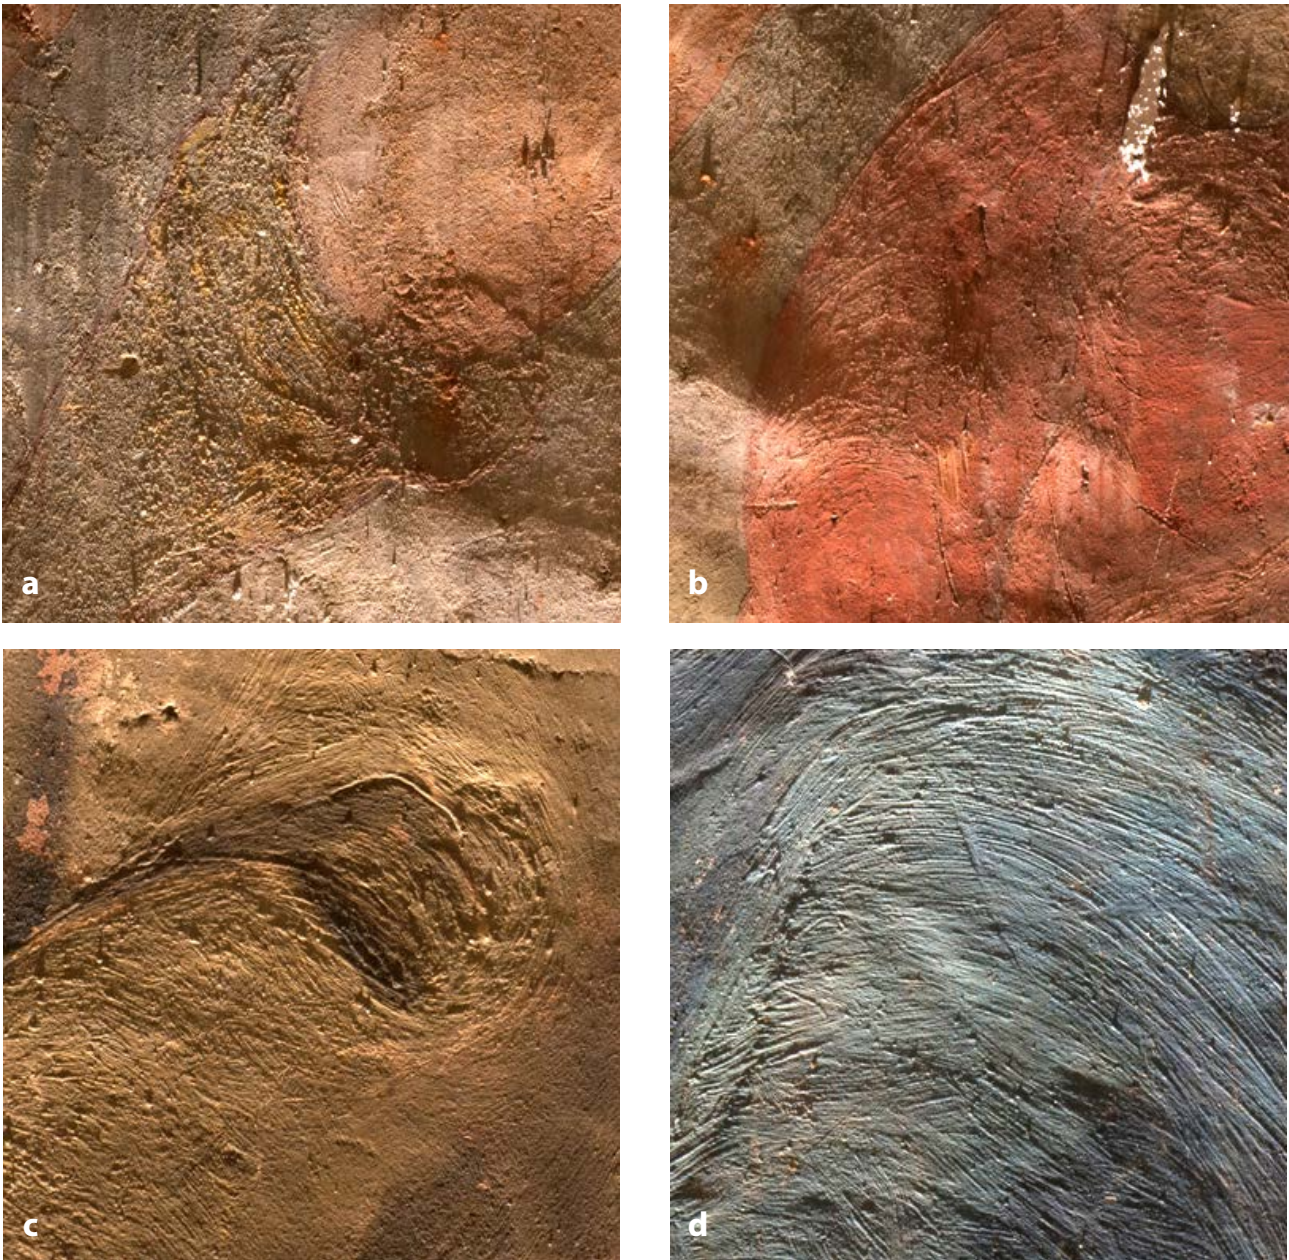
Figure 6. Scene 4 and 6, details. Raking photos document the application of thick brushstrokes of paint.

thickness in a manner analogous to that of oil painting. This feature is described by Andrea Pozzo in *sezione decima* of *Perspectiva Pictorium and Architectorum*, published by the first time in 1692 and re-edited during the eighteenth century [8]. These mural paintings seem to follow this aesthetic and painting method. Thick brushstrokes are visible in all the scenes, especially on the blue clothing modeling (Figure 6). It is impossible to reach this effect only applying pigments mixed with water (*buon fresco* technique). The addition of a binder to the pigments, such as lime or an organic substance, was necessary. The technique of lime fresco was well known from the Byzantine and Romanesque ages and it also allowed the execution time to be extended beyond that of the *buon fresco* technique [8]. The application of

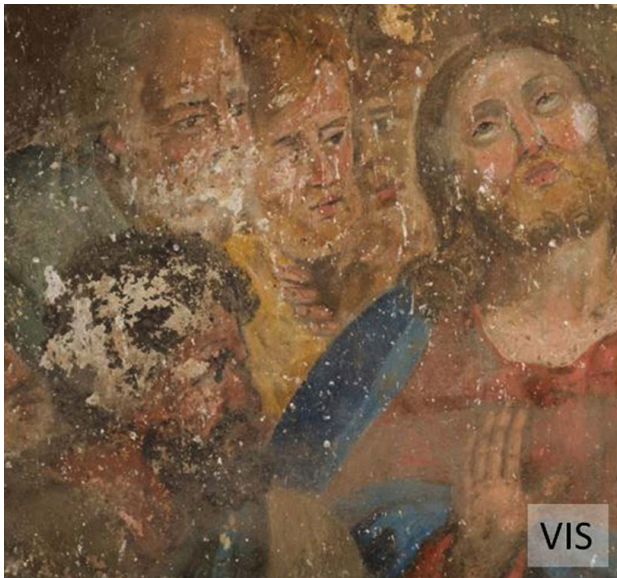
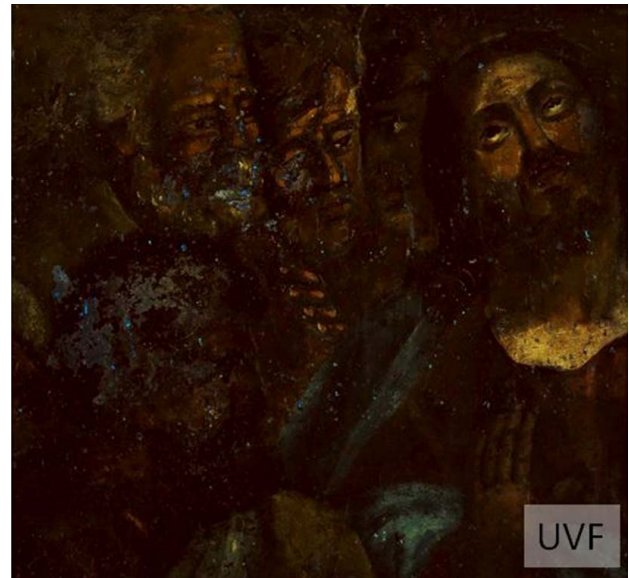
Figure 7. Scene 2, *Last Supper*, detail. Technical photography. The UVF photo shows strong fluorescence which could be assigned to an organic binder.

lime fresco could explain the lack of *giornate* in these paintings. Another hypothesis, suggested by the strong UV fluorescence of some paints (Figure 7), could be the additional use of an organic binder. Further analytical research is needed to confirm either hypothesis; however, the technical photographic documentation in both raking and UV light corroborated the use of mixed techniques in the execution of the mural paintings.

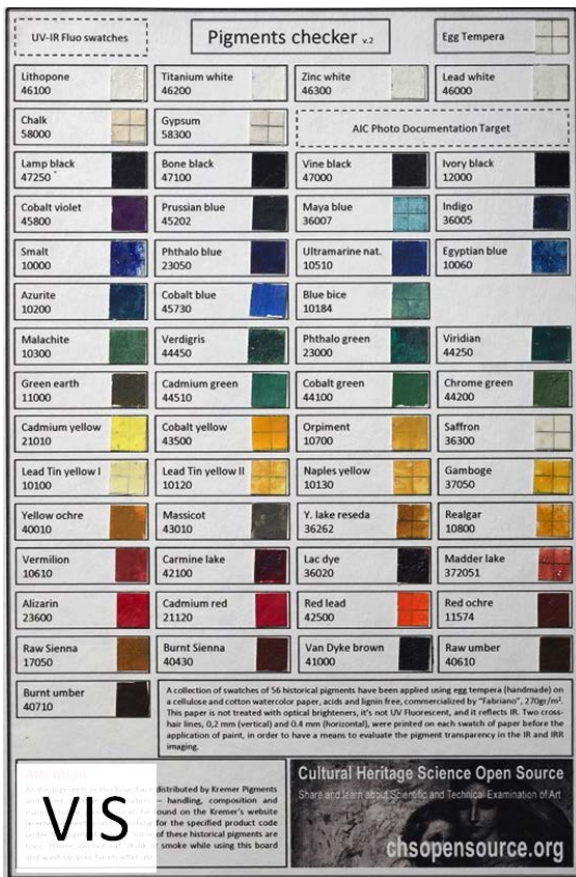
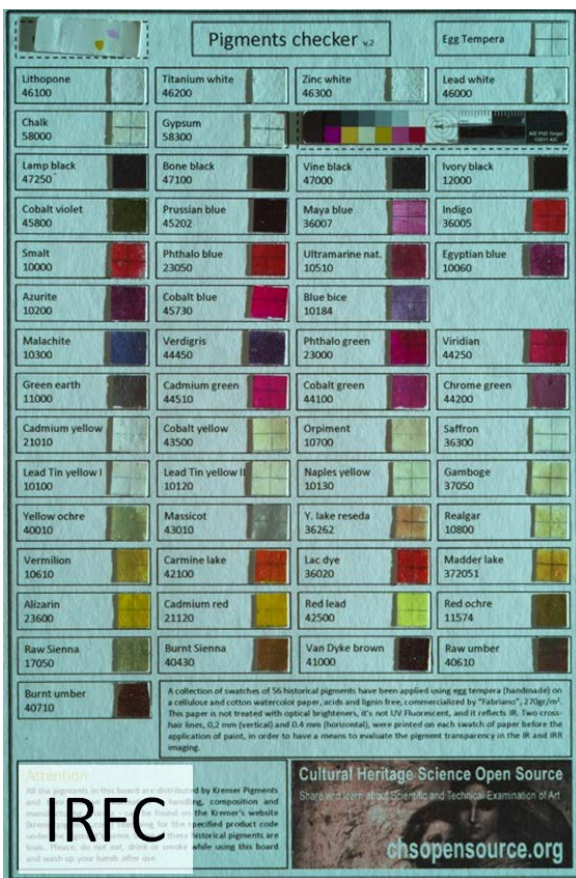
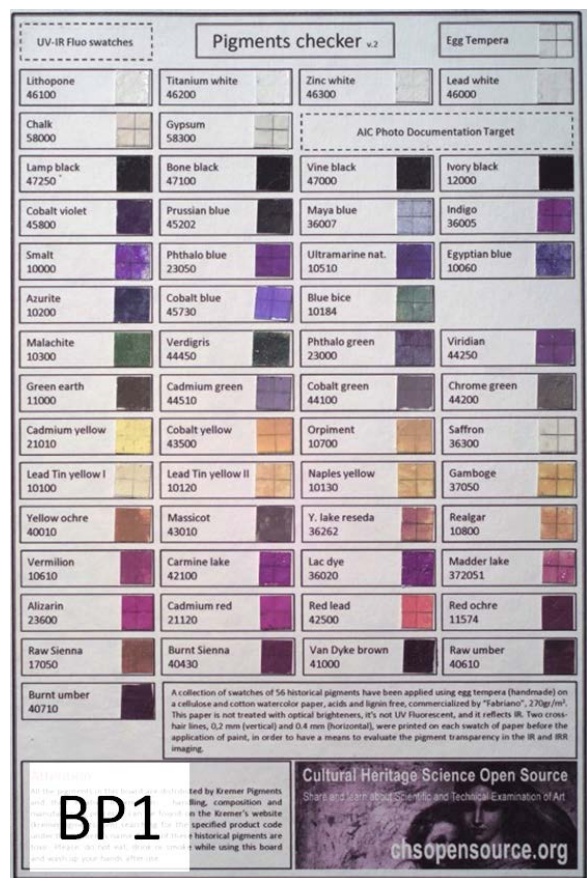
Figure 8. Pigments checker collection of 54 historical pigments laid with egg tempera and tested with the BP1 filter for infrared false color.

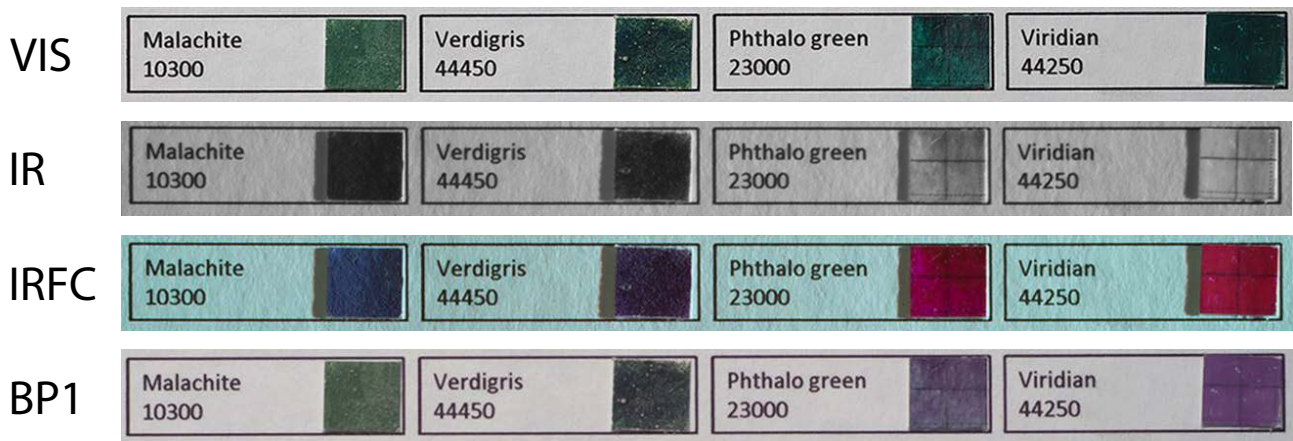
Figure 9. Malachite, verdigris, phthalo green and viridian. Both IRFC and BP1 can differentiate the two historical green pigments (malachite and verdigris) from the modern phthalo green and viridian.

Compared to IRFC, BP1 is less effective since the infrared is also detected by the blue and green photosensors and the capacity to render pigments with different false color is reduced. The advantage of BP1 over IRFC is that no post-processing or editing is needed. Therefore, this method is much faster and it is particularly useful for the study of large artworks, such as mural paintings, since their documentation with IRFC would require the laborious editing of numerous VIS and IR images. Another issue with the BP1 filter is that the images obtained will always be a little bit blurred, the actual amount depending on overall exposure parameters (aperture and distance). A normal lens can focus only one spectral range at a time, visible or infrared. Therefore, if focusing is fine in the visible range, the infrared would be out of focus. This issue could be solved using an expensive apochromatic lens, but for the examination of objects at a long distance and sufficient illumination, a small aperture can minimize the blurring. The filter has been tested on a collection of 54 historical pigments laid with egg tempera (Figure 8). The method differentiates pigments with different infrared behavior, such as malachite and verdigris (both absorb infrared) from the other greens (reflect the infrared) (Figure 9). BP1 seems

therefore a valid method to distinguish retouches over the two historical green pigments. The IRFC and BP1 images from the Kiss of Judas scene are shown as an example (Figure 10). Both of the images do not show any retouches. A preliminary identification of the pigments with non-destructive methods has been realized [4] and the IRFC confirmed the results. The red vest of Jesus was indeed realized with vermilion (HgS) and the green background is green earth, while ocher was used for the brown and yellows. Further study is needed to determine the blue pigment used for the mantle of Christ.

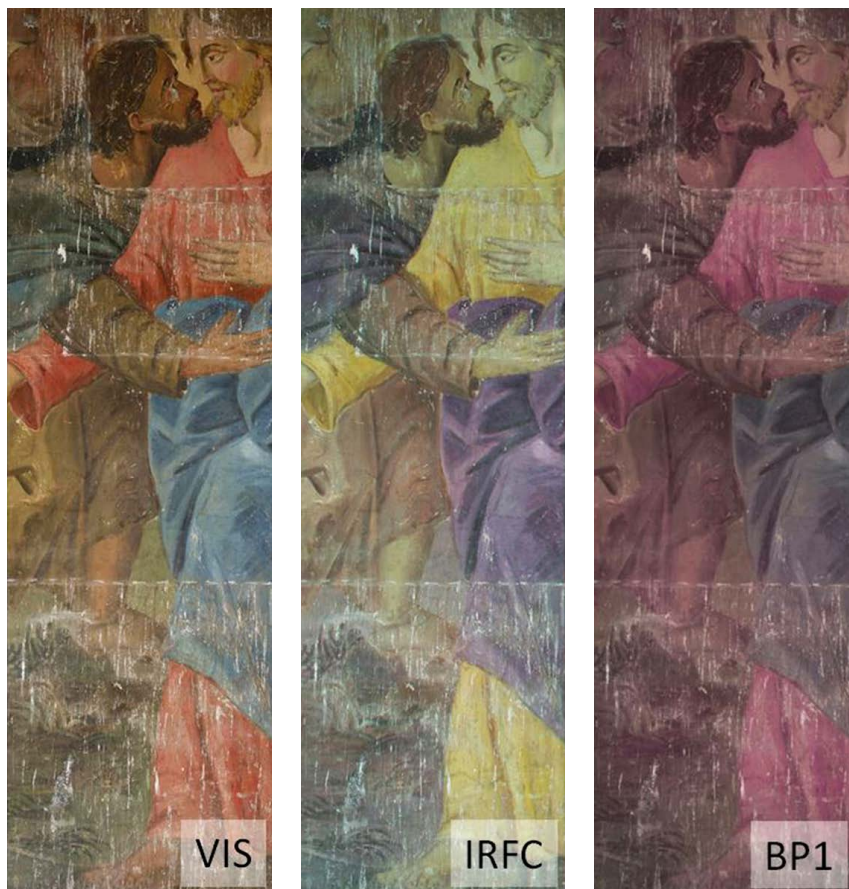
Figure 10. Scene 4, *Kiss of Judas*. IRFC and BP1 confirm the pigments attributions provided by previous non-invasive analysis.
