The newly discovered 18th century wall paintings in Aci Sant'Antonio

The diagnostics campaign.

The Crucifix Chapel.

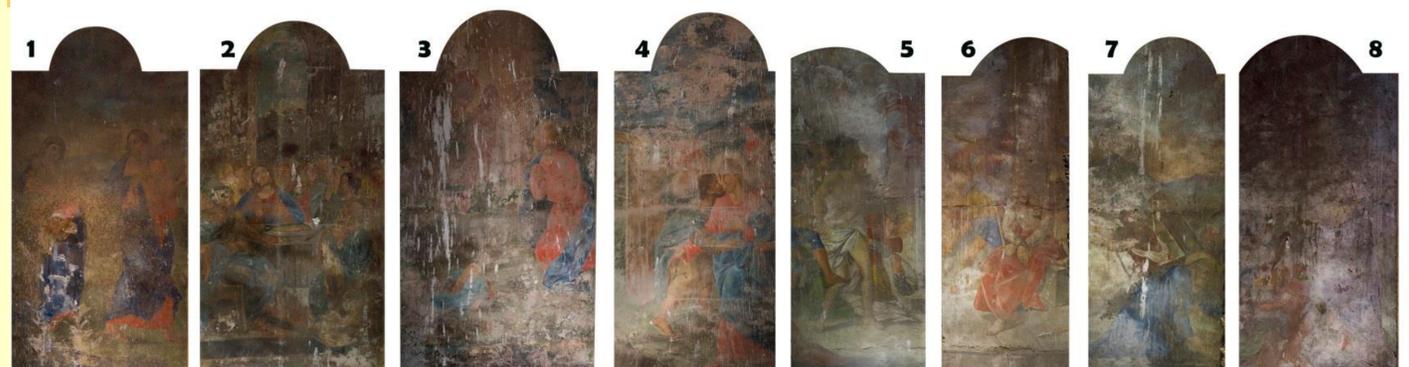
Crucifix Chapel. The 8 surviving scene of the 18th century mural paintings cycle.

The mural paintings were first documented by CHSOS with technical photography (visible, raking light, infrared, ultraviolet fluorescence and infrared false color). Then analytical examination was performed both on-site (with pXRF) by UCSD (USA) and on 7 paint fragments collected from the floor near the murals by the Hercules laboratory (Portugal). The analytical setup comprised optical microscopy, electronic microscopy with x-ray spectrometry (SEM-EDS), X-Ray diffraction (XRD) and μ FT-IR.
