The newly discovered 18th century wall paintings in Aci Sant'Antonio

The diagnostics campaign.

The Crucifix Chapel.

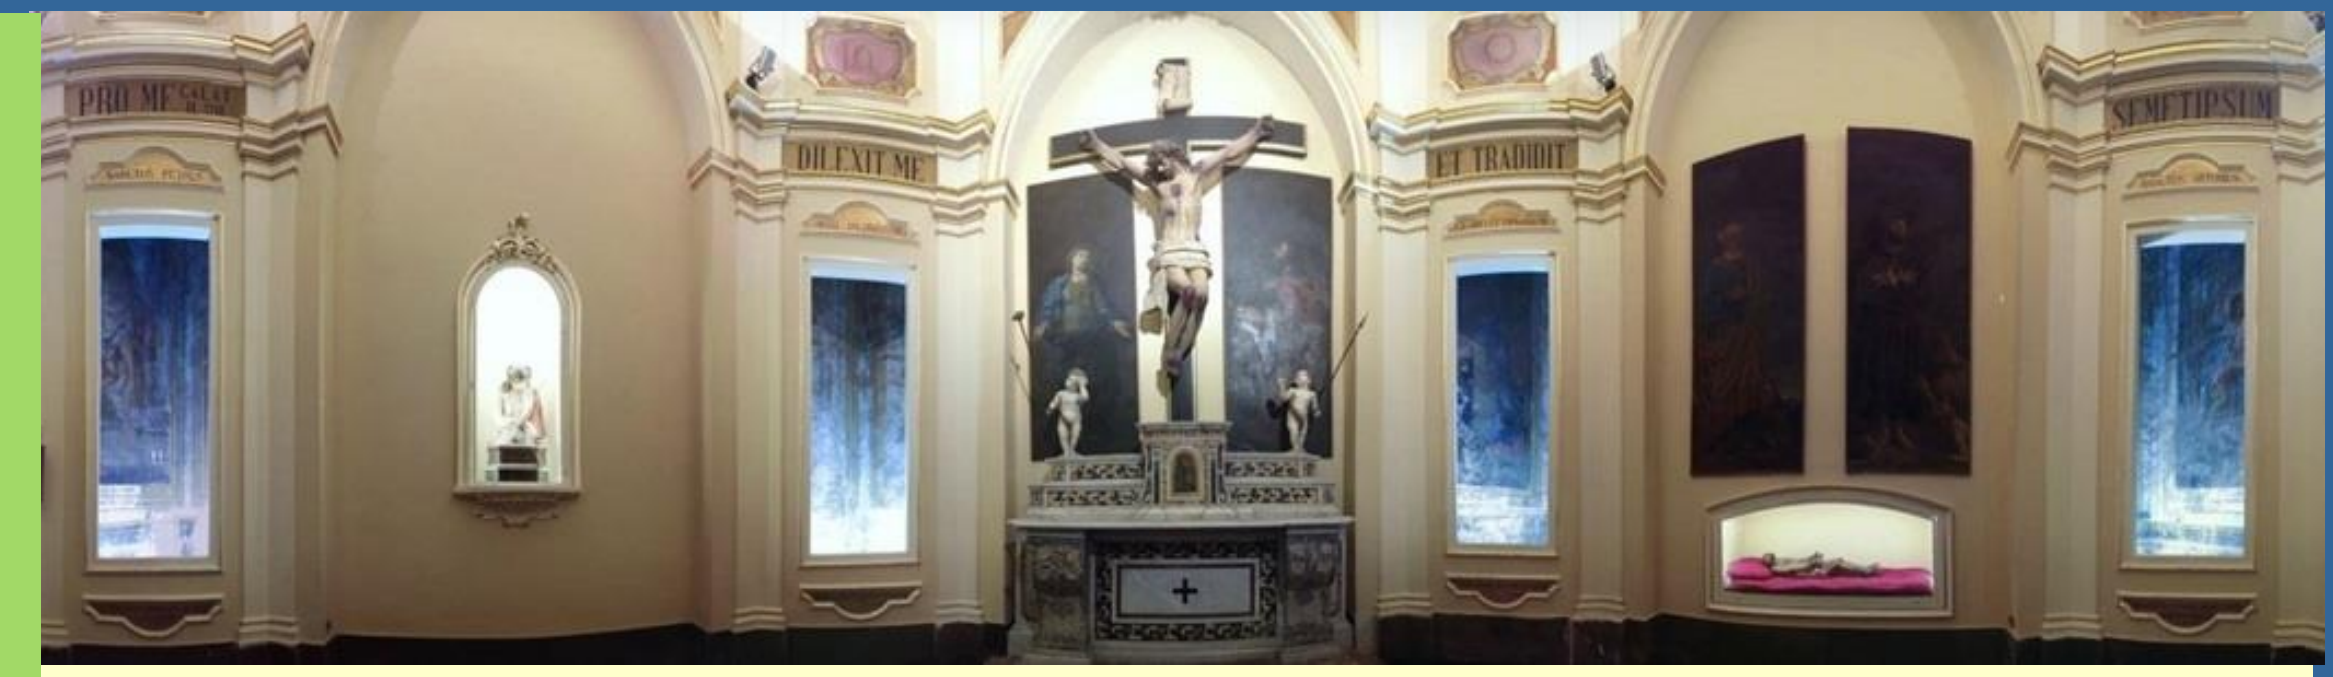
Crucifix Chapel. Split panorama of the chapel after the renovation.

A cycle of 18th century mural paintings was revealed in 2012 during maintenance works in the Crucifix Chapel of the Mother Church in Aci Sant'Antonio. The paintings have survived along the corners of the originally square chapel that was altered in the early 20th century, acquiring the current octagonal-shaped construction. All of the murals except the scenes on the corners have been destroyed and irremediably lost. The murals are in need of immediate conservation treatment and thanks to international academic collaborations promoted by CHSOS diagnostic documentation and conservation assessment have been performed in order to inform the planning and elaboration of the conservation project.

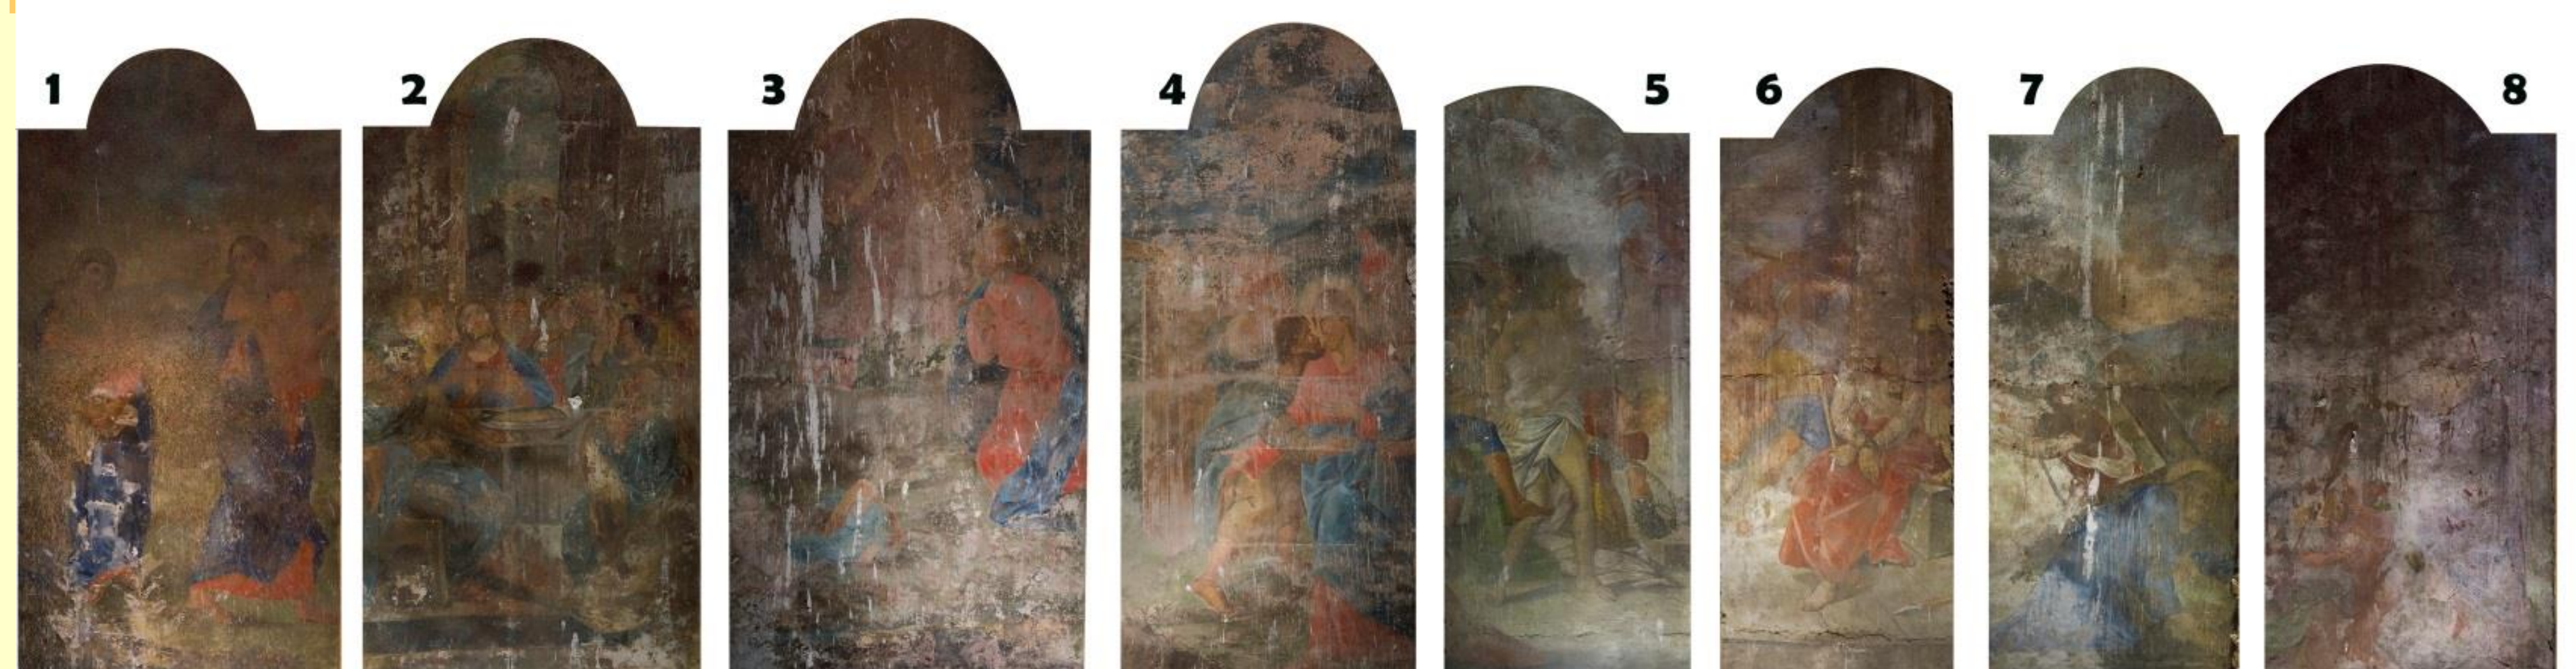
Crucifix Chapel. The 8 surviving scene of the 18th century mural paintings cycle.
